Docket No. 217 – Development and Management Plan Inspection

Date: February 20, 2004

Location: Norwalk Substation Expansion

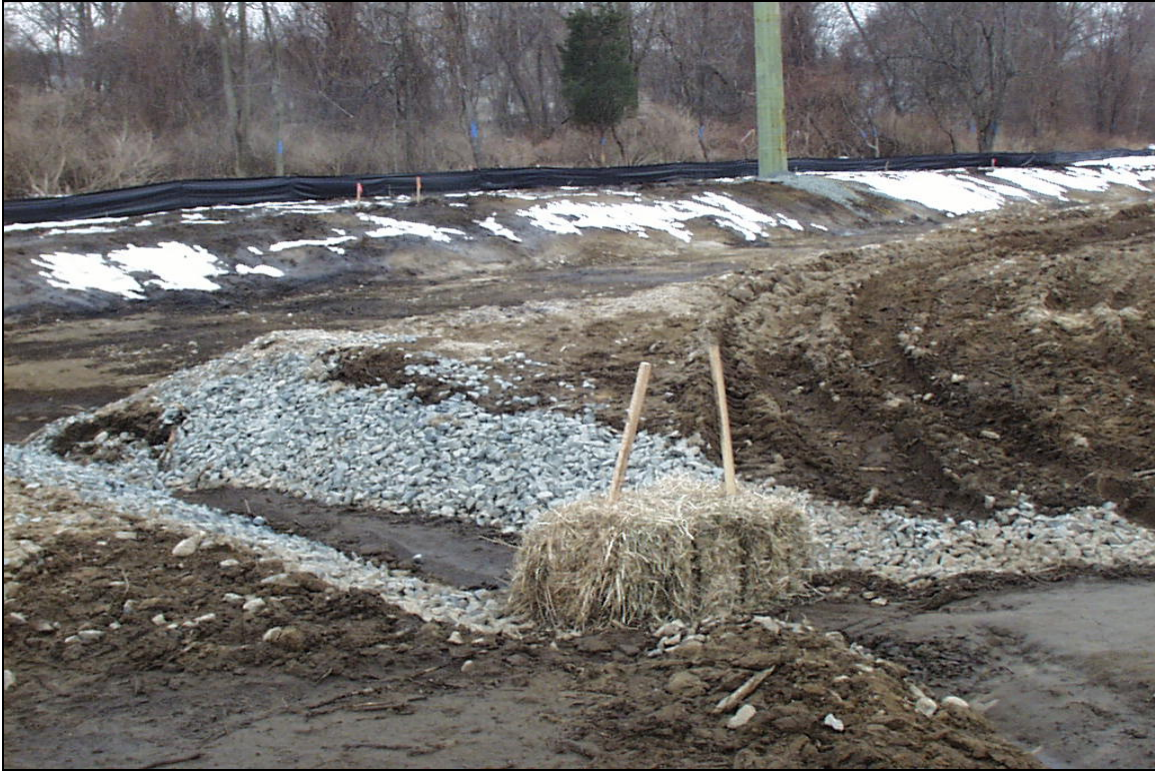
A CHECK DAM WAS PLACED IN ORDER TO HELP CONTROL SEDIMENT ENTERING THE TEMPORARY BASIN. THIS MAY HELP TO PRESERVE THE CAPACITY OF THE BASIN. 2/20/04

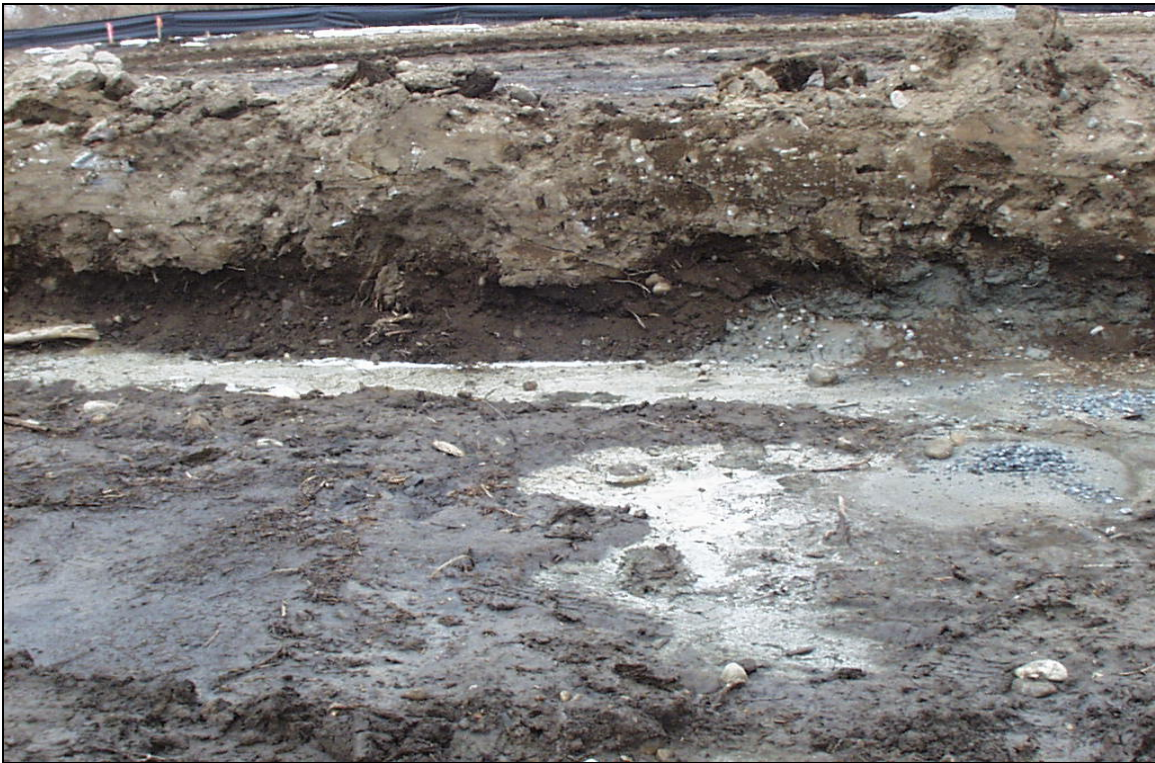
VIEW OF A SMALL CONCRETE WASHOUT ON THE GROUND NEAR THE OUTSIDE BERM FORMED BY THE BASIN. THE AREA SHOULD BE DESIGNATED AS A WASHOUT AREA AND CONTAINED 2/20/04

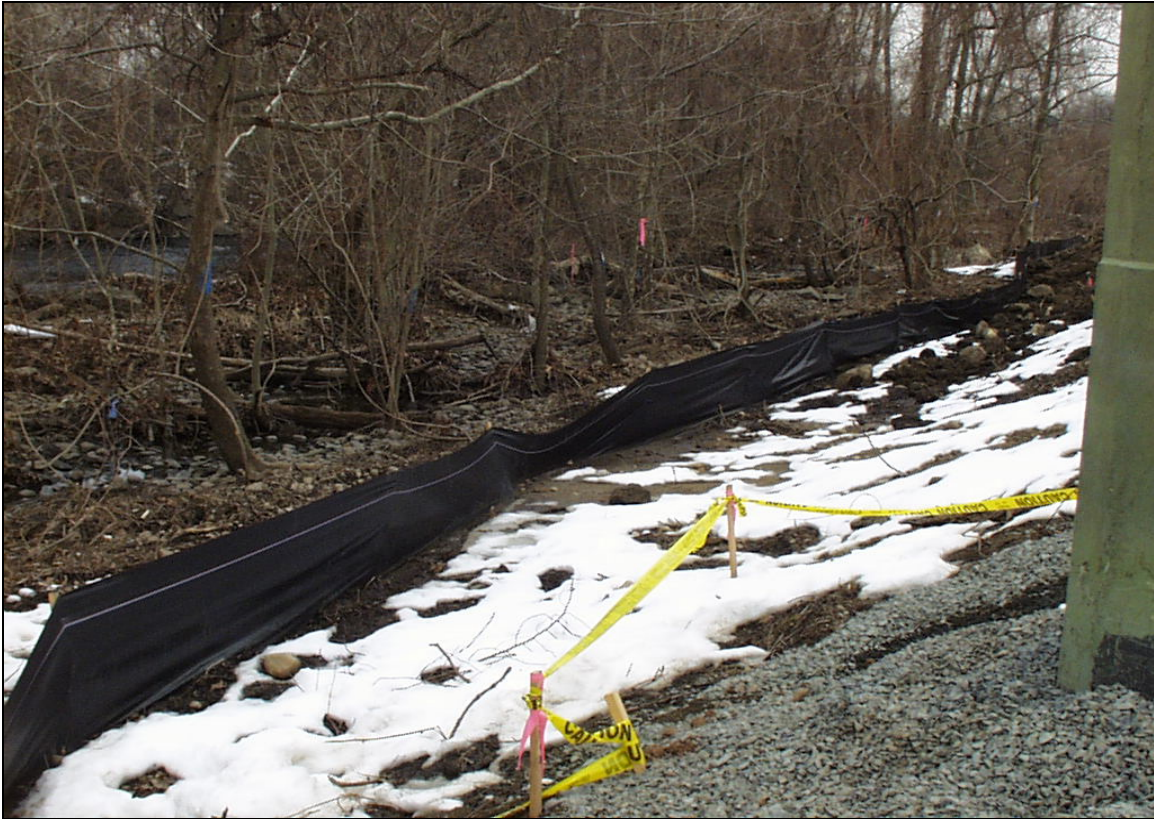
THE SILT FENCE BEHIND THE STOCKPILE IS STILL HOLDING UP WELL. 2/20/04

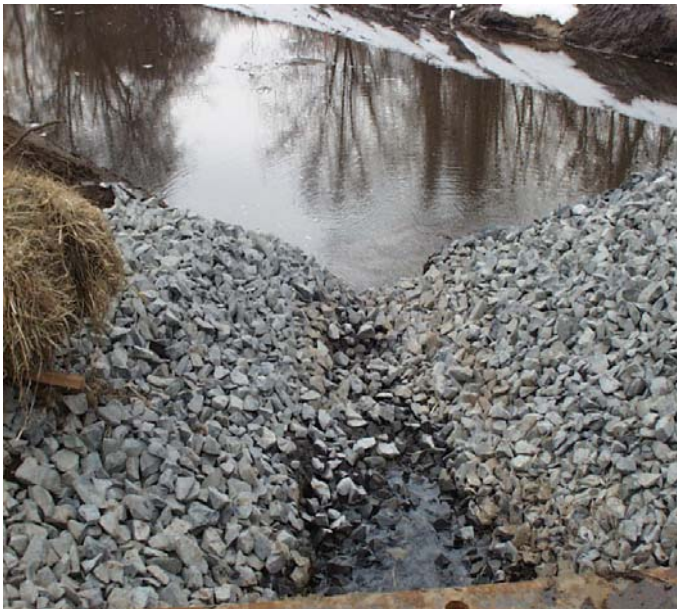
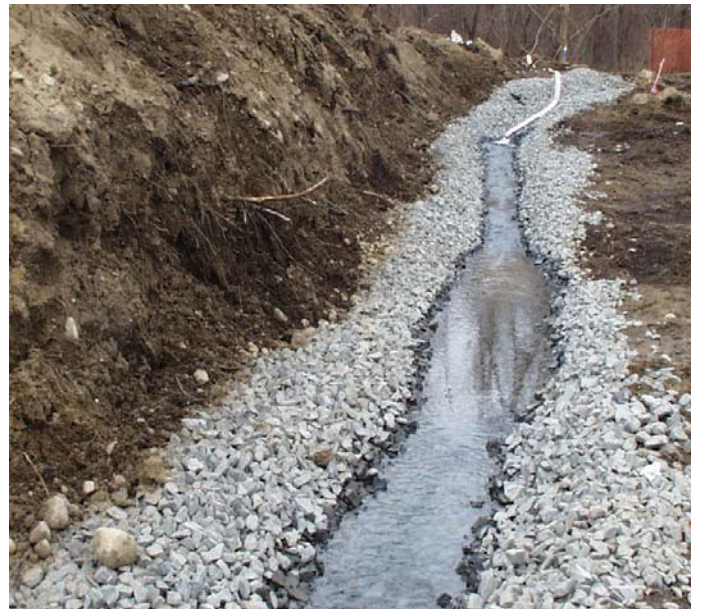
VIEW OF DEWATERING FLOWS BEING DISCHARGED TO THE RIPRAP SWALE LEADING TO THE TEMPORARY DETENTION BASIN. THE WATER WAS VERY CLEAR ALONG THE ENTIRE PATHWAY AND WAS APPROPRIATELY DIRECTED. 2/20/04

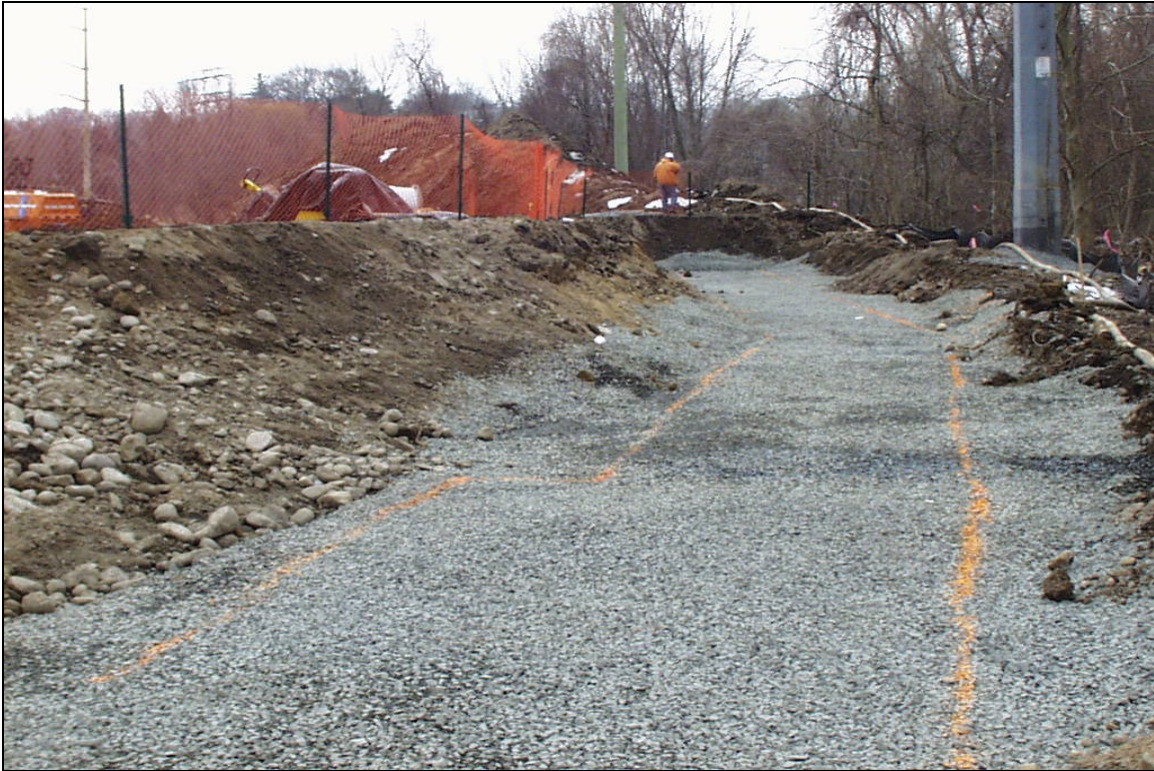
FOUNDATION AND BASES BEING PREPARED FOR THE CONSTRUCTION OF THE RETAINING WALLS ON SITE. THIS IS FAIRLY CLOSE TO THE RIVERBANK. 2/20/04

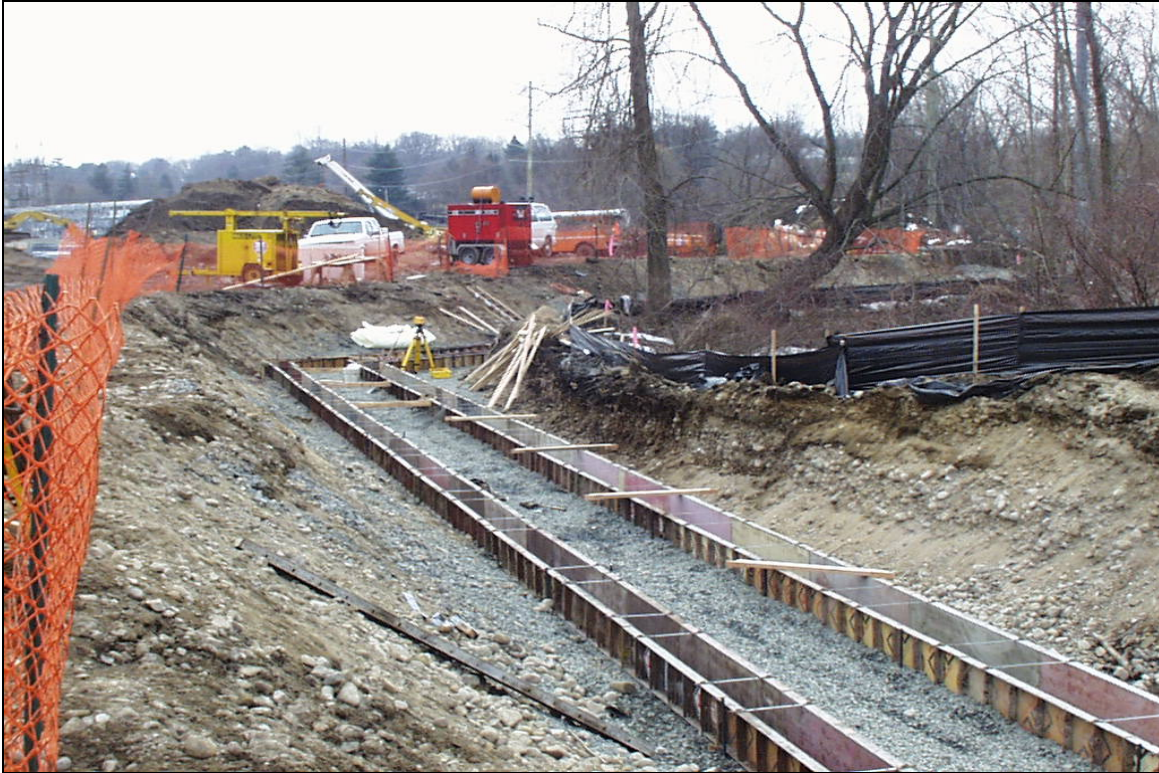
MORE VIEWS OF THE RETAINING WALL FOUNDATION. CONCRETE WAS ALMOST READY TO BE POURED IN THIS LOCATION. 2/20/04

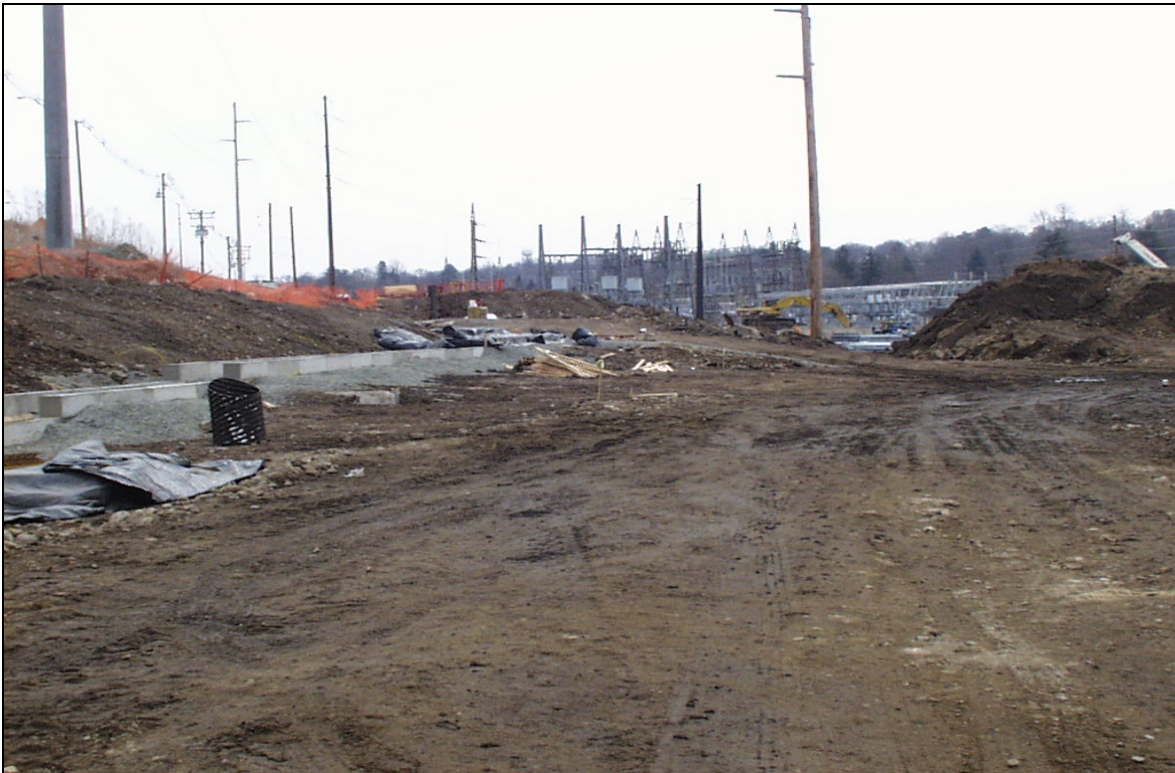
OVERVIEW OF PREVIOUSLY EXCAVATED AREA INCLUDING NEW STOCKPILE ON SITE . 2/20/04

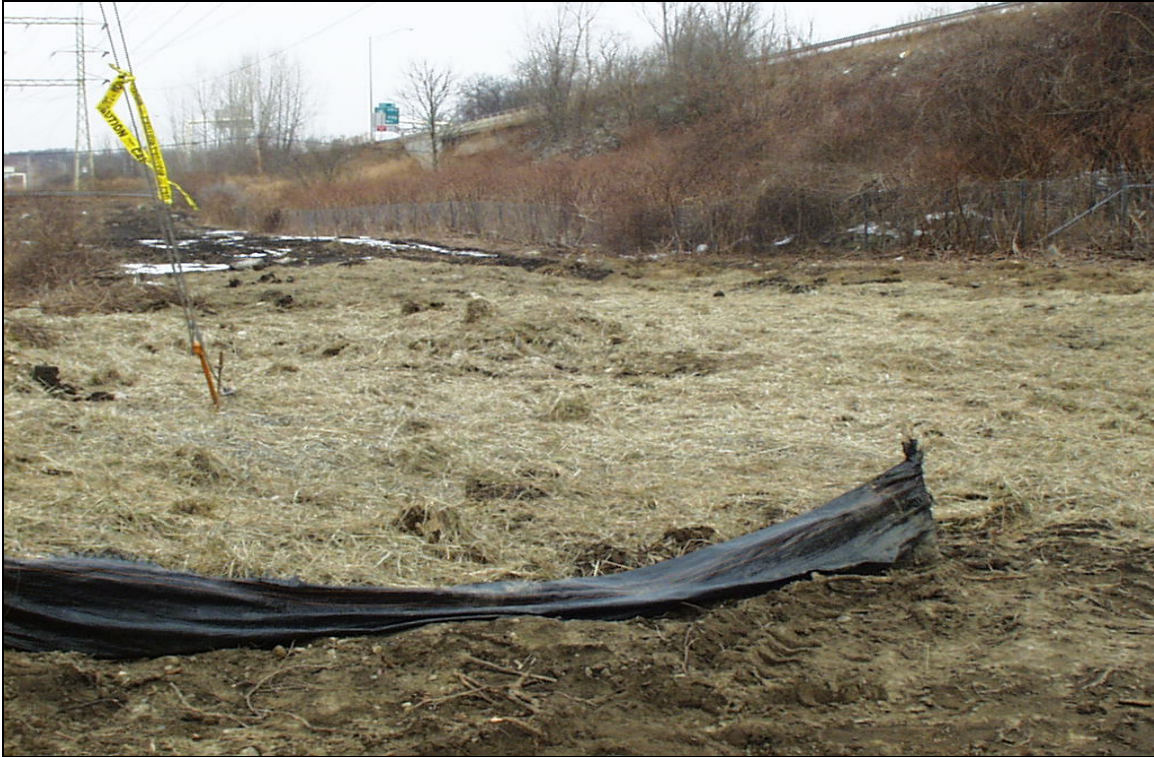
VUE OF AREA AT NORTHERN END OF THE SITE. SOIL HAS BEEN GRADED BACK AND THE AREA HAS BEEN MULCHED. WHEN WORK COMMENCES HERE IN THE FUTURE, SILT FENCE SHOULD BE EXTENDED TO ENCOMPASS IT. 2/20/04
